## Water Compliance Inspection Report

**NPDES  
Inspection Report**

**Edaleen Dairy, LLC**

**March 31, 2010**

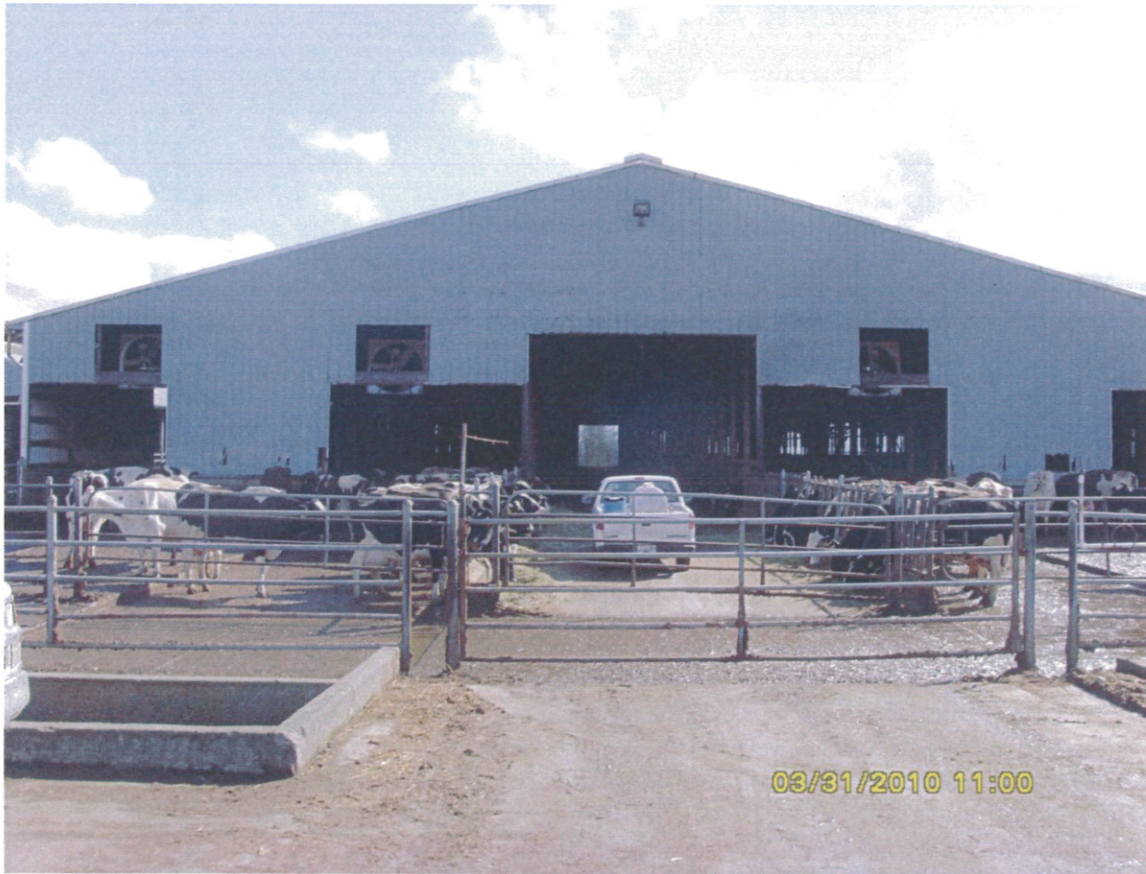
Photo #1: View of the confinement area at F1 (Facility 1).

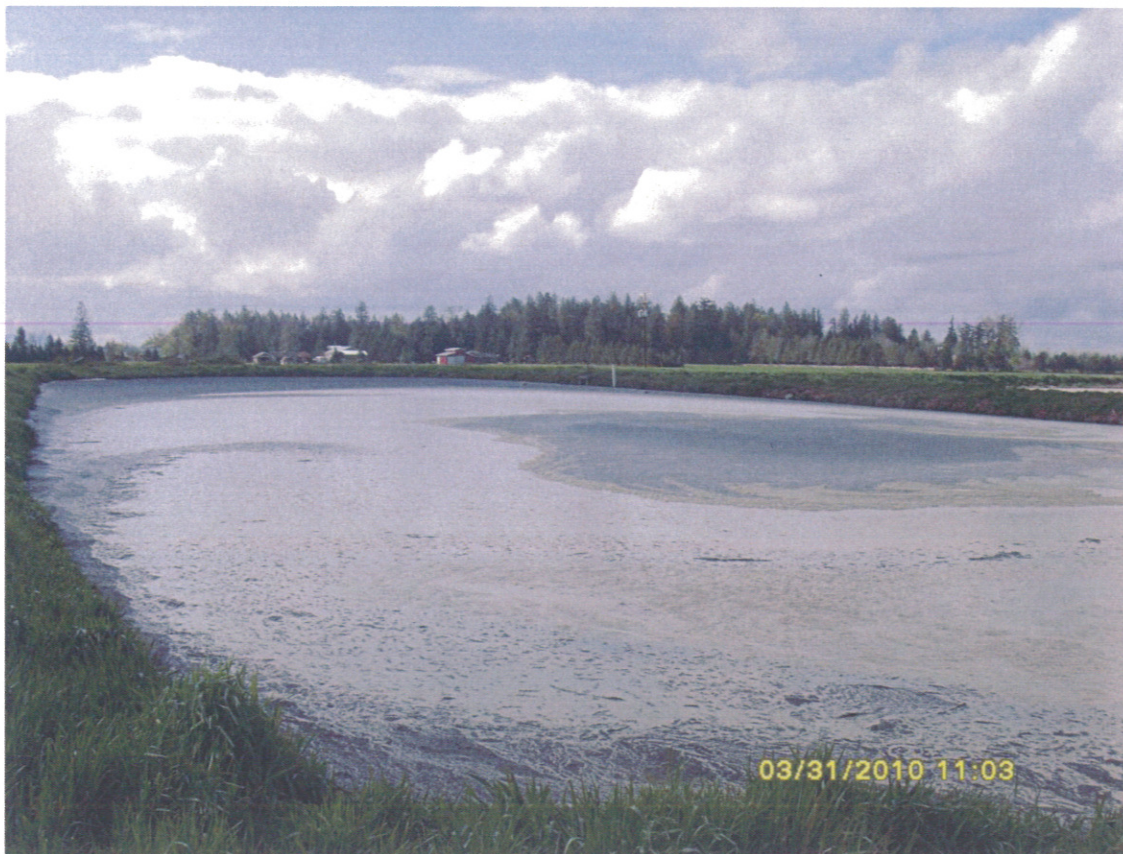
Photo #2: A view of one of two waste storage lagoons located at F1.
